# Foamex Plant Fire

## Photo Log

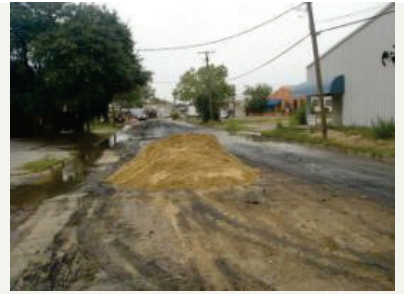
Description: Preparing to make earthen berm on west side of site

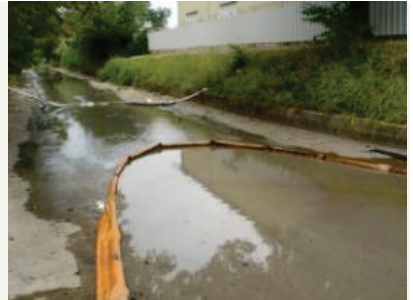
Description: Boom Location 1 at creek near Maybank Street and Lombardy Road

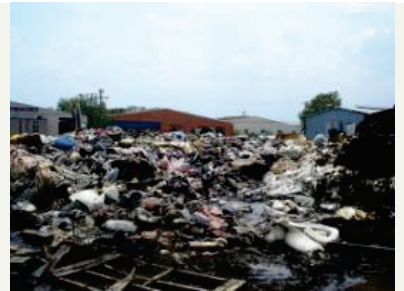
Description: Closeup of burned material at facility

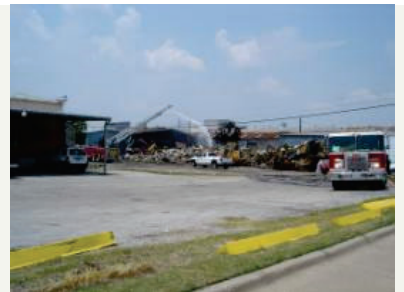
Description: Dallas FD putting out hot spots at burned facility
